Inspection Report

Property Address:
1234 N. Gilbert Rd.
Gilbert AZ 85258

Date: 7/21/2017	Time: 02:30:00 PM	Report ID:
Property: 1234 N. Gilbert Rd. Gilbert AZ 85258	Customer: John Smith	Real Estate Professional:

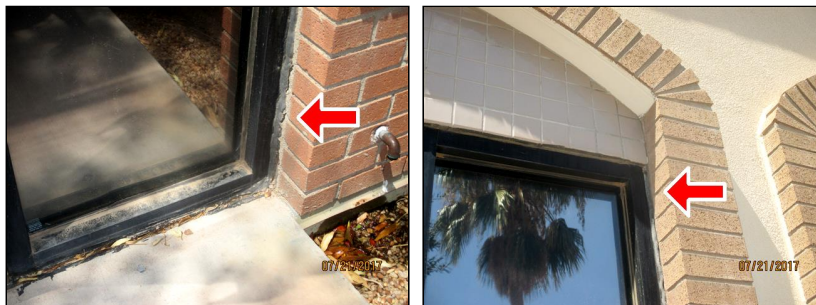
2.1 Exterior Walls Cladding/Flashings

(1) Caulk/seal **all** gaps, cracks and openings at the exterior walls - Review.

(2) An east side wall vent was missing it's cover - Attention.

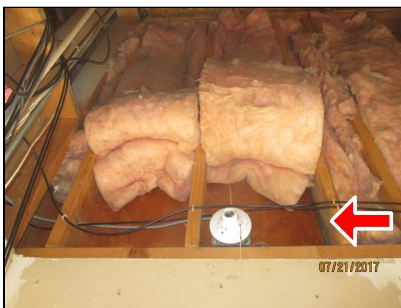
3.1 Insulation Condition/Issues

Insulation was displaced in areas, correction suggested - Attention.

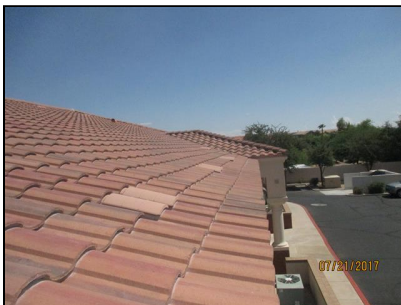
4.0 Concrete Tile Roof

(1) The tile roof is older (the normal service life of a tile roof is between 20 - 30 years) - Review.

(2) The concrete tile roof appeared Satisfactory.

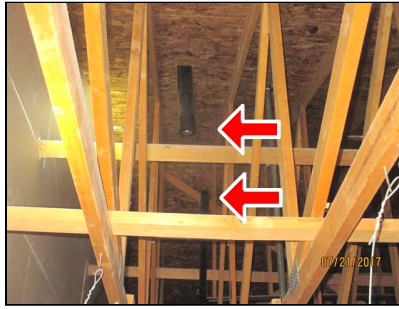
6.3 Waste/Vent Piping

Disconnected waste piping noted in the attic - Attention.

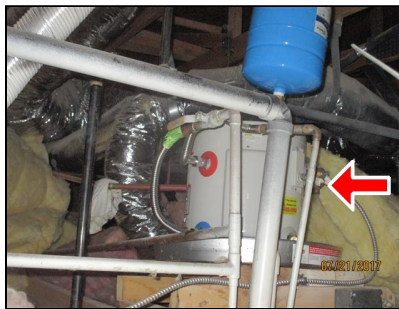
6.5 Electric W/H Operation

Water heater was Operational but could not be fully accessed - Review.

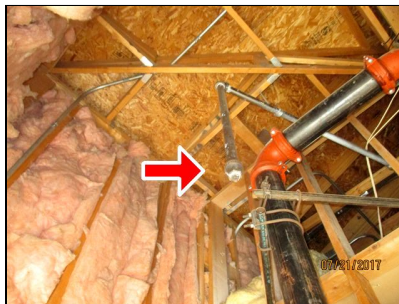
6.6 Fire Sprinklers

The structure is equipped with fire sprinklers and piping which were not evaluated as part of this inspection. Missing sprinkler head noted in the riser room - Review.

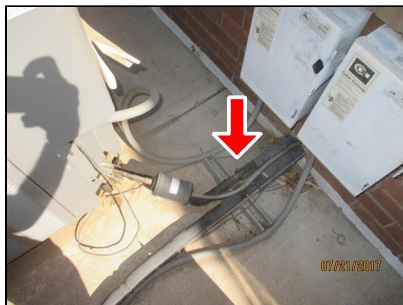
7.4 Cooling System Issues - General

Insulation was damaged at the cooling system refrigerant lines, replace as required - Review.

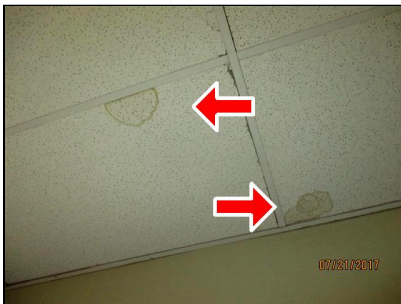
9.4 Walls & Ceilings

Moisture stains noted at the SE janitor closet ceiling - Review.

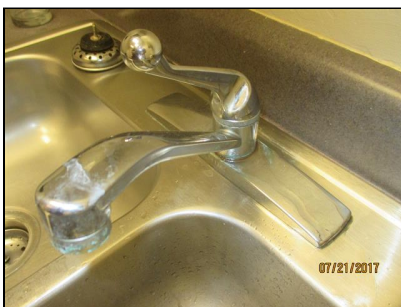
10.3 Sink Faucet and Supply Piping Issues

The kitchen sink faucet leaks around the stem and should be repaired - Review.

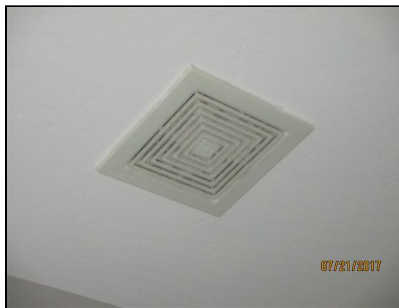
11.2 Ventilation

The bathroom vent fan grill(s) are dirty - Review.
