# General Summary

**Inspection Date: 8/3/2018**

**Inspection Address**

25567 E. South Street

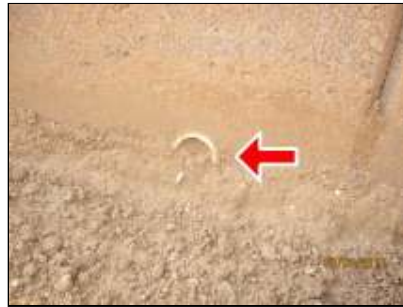
(1) Clogged weep holes noted at the back fence - Review.

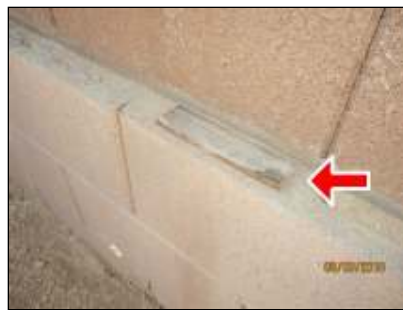
(2) Sharp shims noted at the back fence - Review.

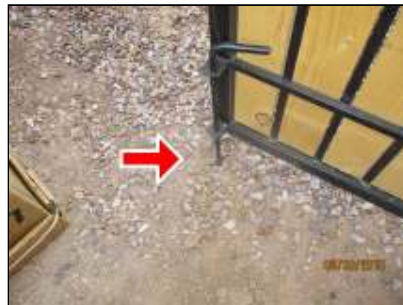
(1) Missing pin holder at the lower gate latch - Review.

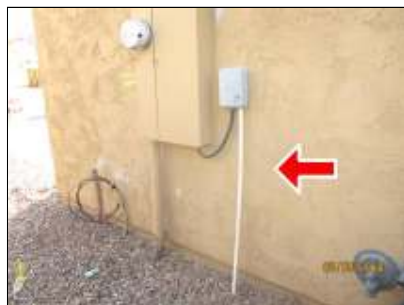
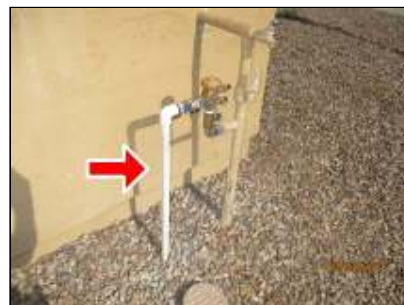
Exterior PVC lines should be painted to protect from the sun - Review.

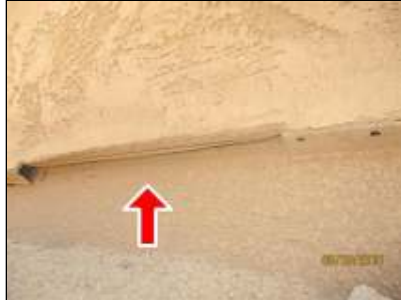
- (1) Caulk/seal **all** gaps, cracks and openings at the exterior walls - Review.
- (2) Missing weep screed section noted at the south exterior - Attention.

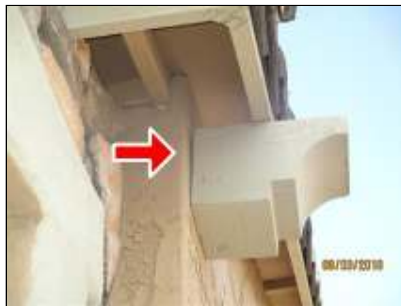
Loose trim was observed at the property - Review.

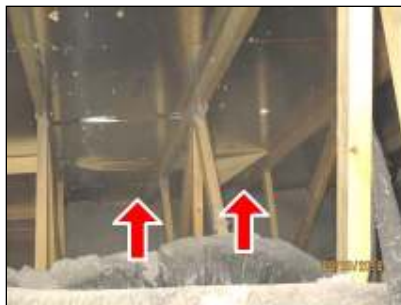
- (1) Loose/unsecured radiant barrier noted above the master b/r - Review.

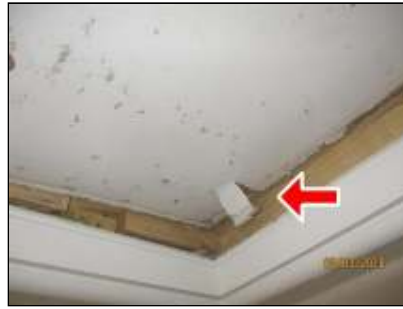
- (2) The attic access panel was slightly damaged - Review.

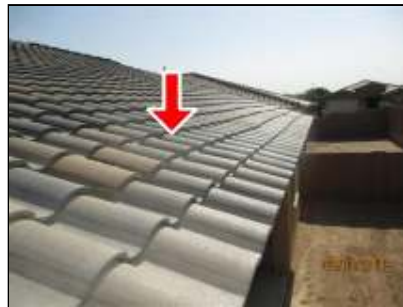
(1) Roof tiles are not properly fastened (3 course at perimeter) to prevent wind damage at the south roof - Attention.

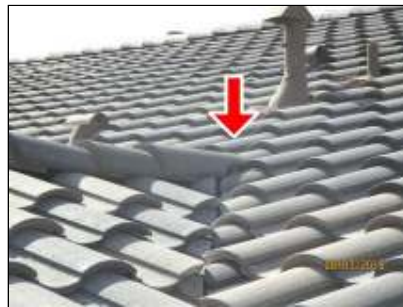
(2) Missing/damaged large garage roof mortar pack noted - Review

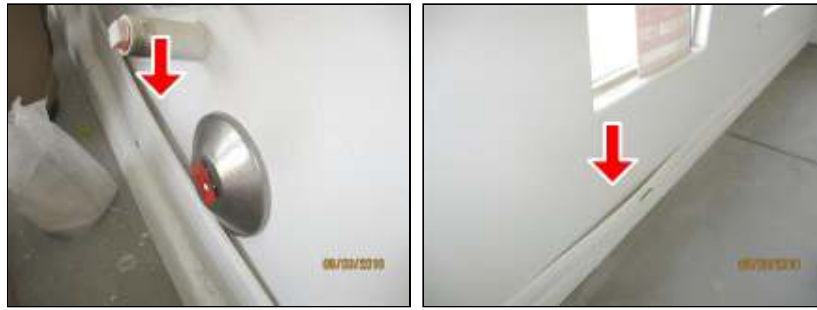
Loose/unsecured base board noted at both garages - Attention.

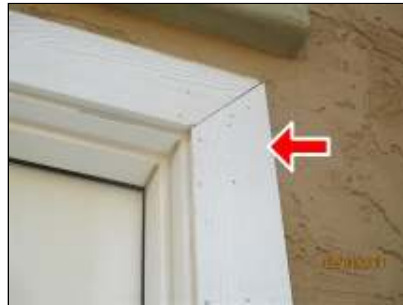
The garage (service) door to the side yard needs caulking at the exterior trim - Review.

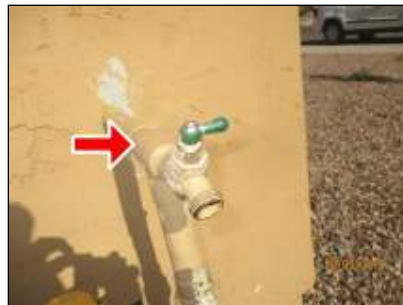
The east hose bib handle was damaged and the handle will need replacement - Review.

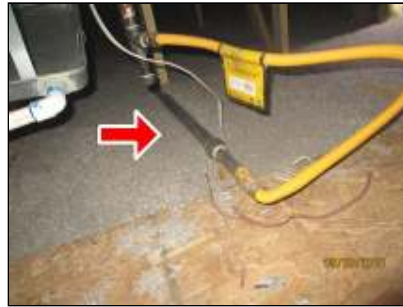
Gas piping was not properly anchored/supported at the attic furnace - Attention.

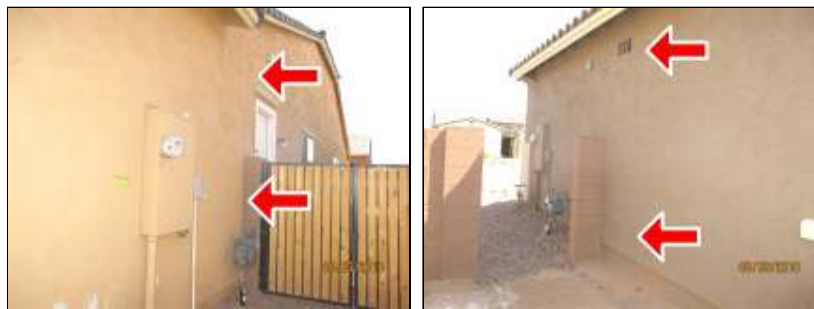
Neighbors

There are no vents in the garage to provide combustion air for the water heater and all neighbors have the vents - Attention.

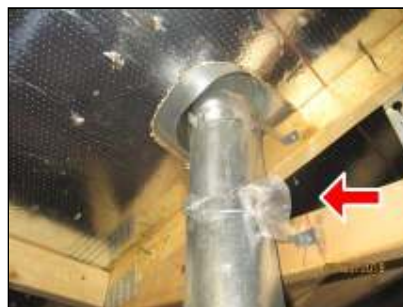
The heating system flue vent pipe(s) are too close to combustibile material. A single-walled vent pipe should be six inches away from any combustibile material, and a double-walled vent pipe should be one inch away - Safety Note/ Review.

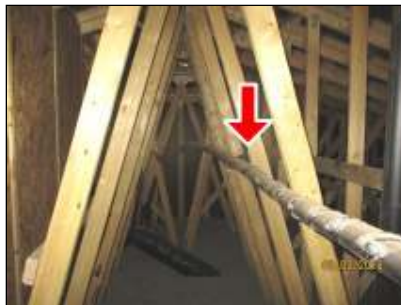
Refrigerant line in the attic is not properly secured - Review.

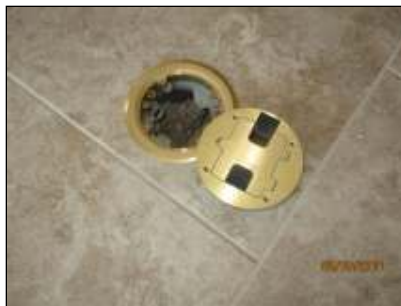
(2) Loose outlet cover noted at the family rm. floor - Review.

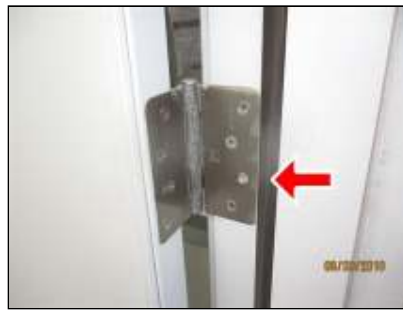
(3) Missing exterior hardware noted at the garage side service door - Review.

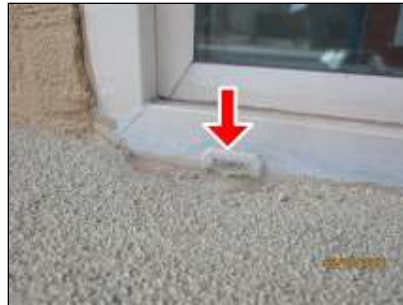
- (1) Clogged window weep holes noted - Review.

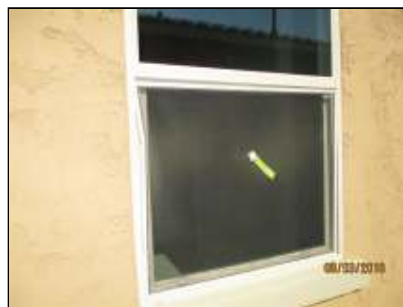
Loose/damaged east window screen noted - Review.

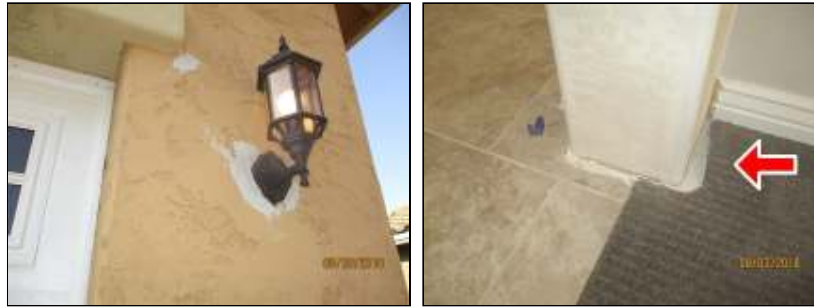
Fit/finish is not yet complete - Review.

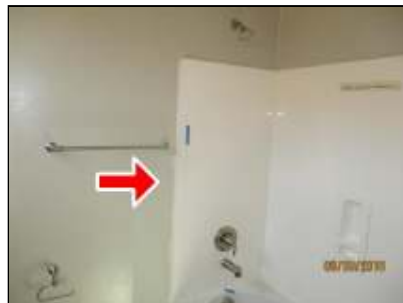
Recommend caulking or grouting at the tubs-showers as required - Attention.
