# General Summary

**Inspection Date: 7/6/2017**

**Inspection Address**

123 E. Main Drive

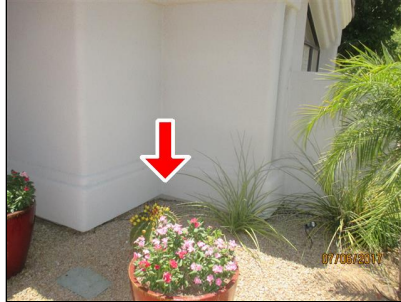
### 1.0 Site Grading and Drainage

- (1) Site drainage was poor at the NE, alterations are suggested to control water flow and keep it away from the building - Attention.
- (2) Rock/soil was too high at the north structure perimeter - Review.

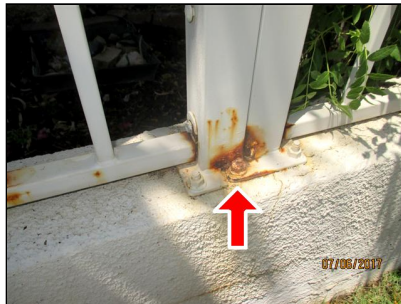
### 1.5 Fence

- (1) Moderate cracks noted at the fence - Review.
- (2) Trees/vegetation are planted close to the fence - Monitor.
- (3) Prior fence repairs noted - Consult Seller/Review.
- (4) Rust noted at the metal fence - Review.

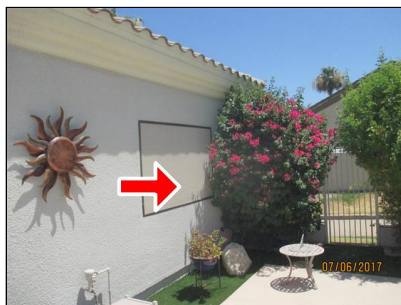
### 1.7 Issues - Vegetation Concerns

Vegetation was encroaching on the structure. Vegetation should be kept a minimum of twelve inches away from the structure for the general welfare of the walls and foundation - Review.

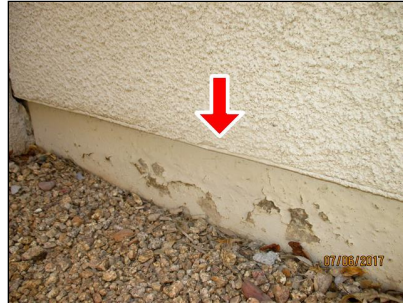
(1) Stem wall surface paint/finish was damaged - Monitor.

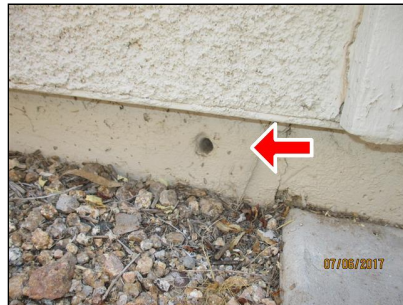
(2) Void in the east stem wall need to be patched as required - Review.

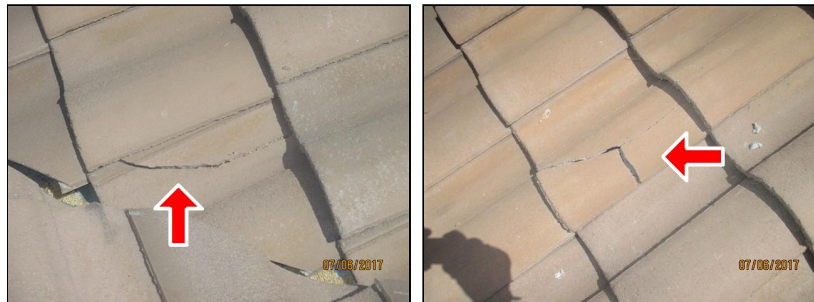
(1) Several cracked/broken roof tiles were observed - Review.

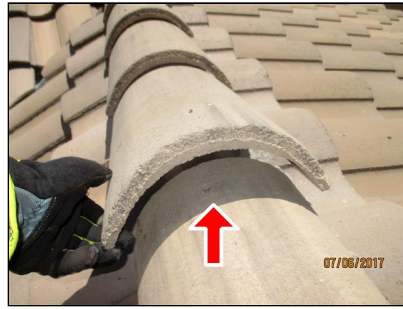
(2) Ridge tiles are not properly secured - Review.

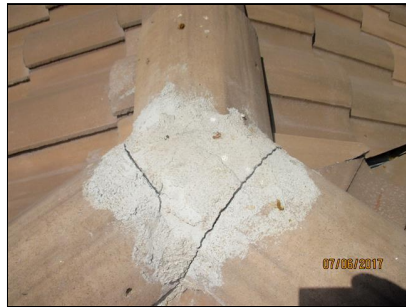
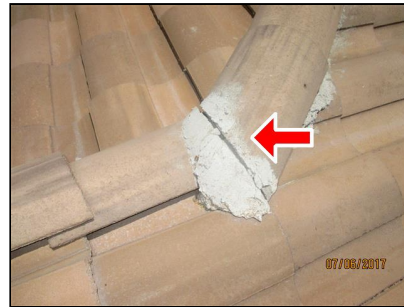
(3) Cracked/damaged mortar pack(s) noted - Review

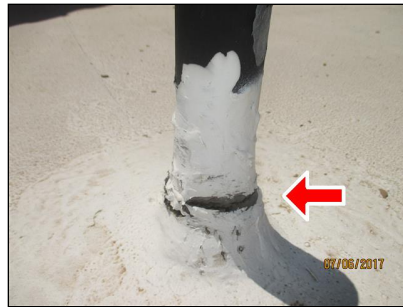
#### 4.1 Flashings

Flashing separations noted at the plumbing stack vent pipe above the garage - Review.

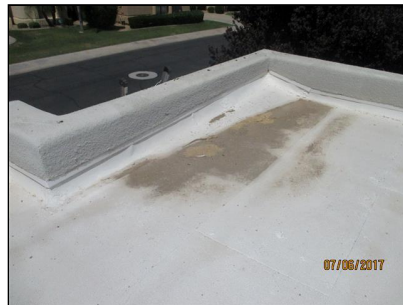
#### 4.2 Rolled Composition Roof

Ponding is evident at the rolled composition roof - Monitor.

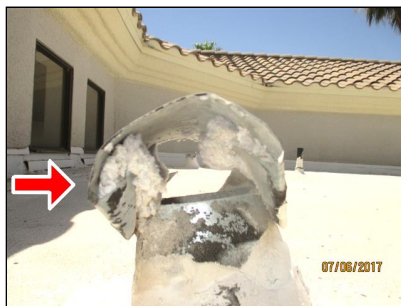
### 6.1 Dryer Vent

Partially blocked dryer vent found, attention needed - Attention.

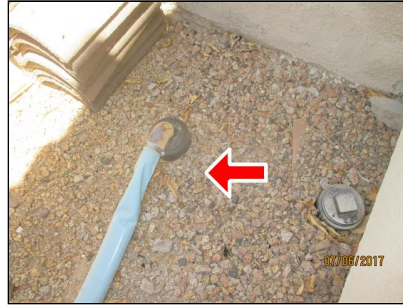
### 7.6 Waste and Vent Piping

Pool backwash hose was connected to the main cleanout - Review.

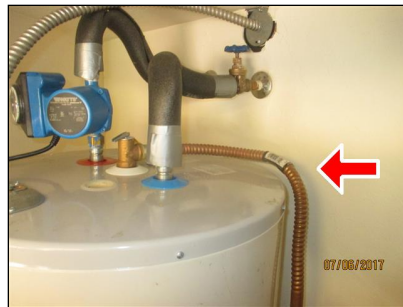
### 7.11 TPR Valve

The water heater TPR safety valve discharge pipe was plumbed with a flexible connector which is not allowed in some jurisdictions and can cause warranty companies to deny coverage - Review.

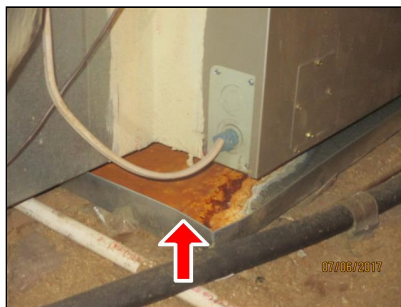
### 8.4 Condensate Issues

The secondary condensate drip pan in the south attic was rusted indicating a prior leak, cooling system evaluation suggested - Review.

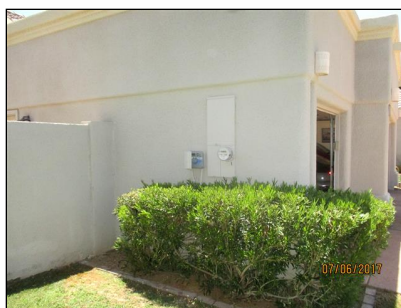
### 9.1 Main Panel

The main panel does not have thirty-six inches of clear space in front of it to facilitate emergency shut-off of the system (correction needed) - Safety Note.

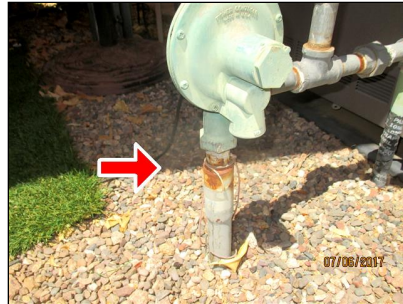
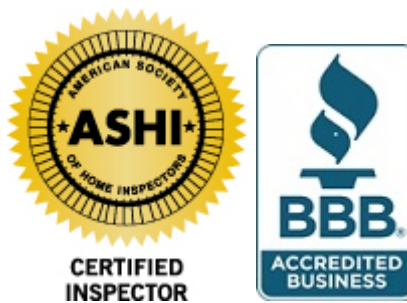
**13.10 Heater**

(1) Rust noted at the heater gas piping - Review.
