## Inspection Report

Property Address:  
1234 E. Main Street  
Lot #20  
Scottsdale AZ 85266

<b>Date:</b> 8/2/2018	<b>Time:</b> 08:00:00 AM	<b>Report ID:</b> 080218
<b>Property:</b> 1234 E. Main Street Lot #20 Scottsdale AZ 85266	<b>Customer:</b> Jane Smith	<b>Real Estate Professional:</b>

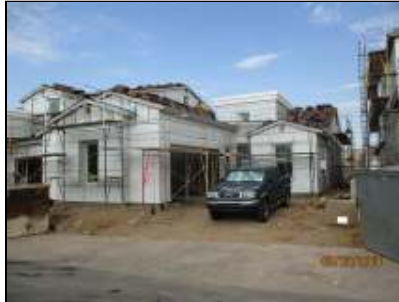
Site has not yet been fully graded.

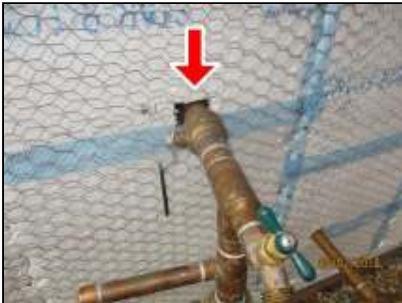
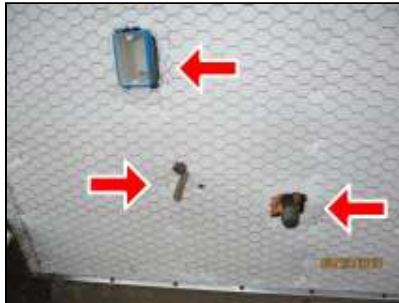
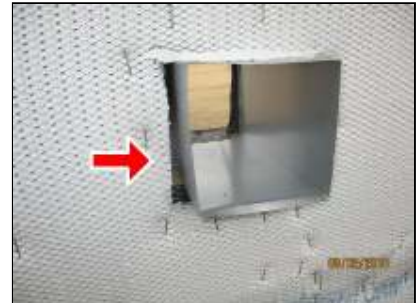
(1) Missing caulking at various exterior locations.

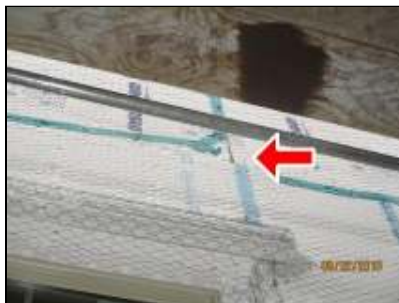
(2) Missing tape at the west exterior.

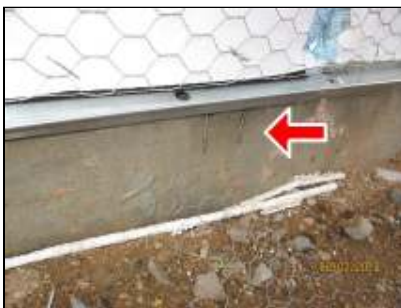
(3) Nails should be removed at the stem walls.

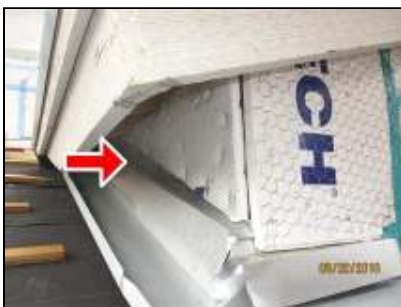
(4) Missing lath at the upper exterior locations.

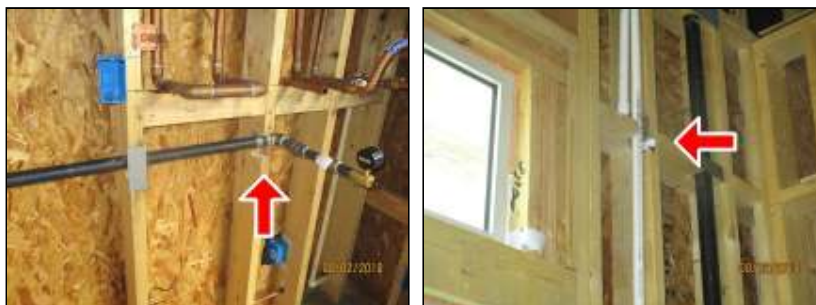
(1) Missing nail guards at various locations.

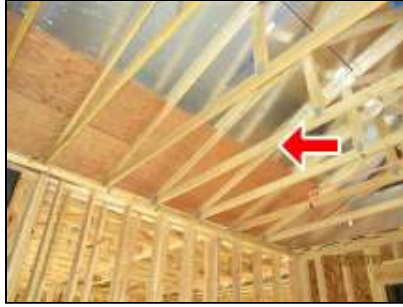
(2) Radiant barrier not installed at all attic locations.

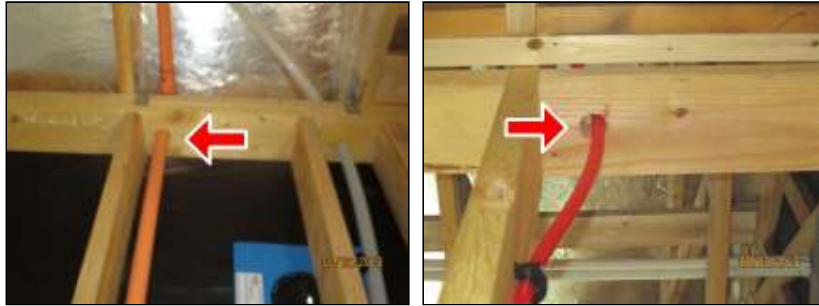
(3) Missing fire caulk noted at various top sill locations.

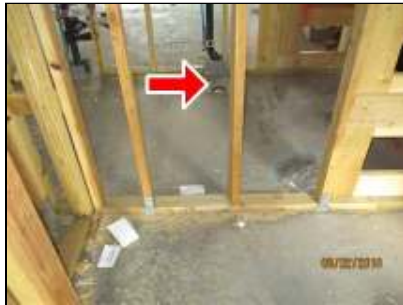
(4) Some warped studs noted.

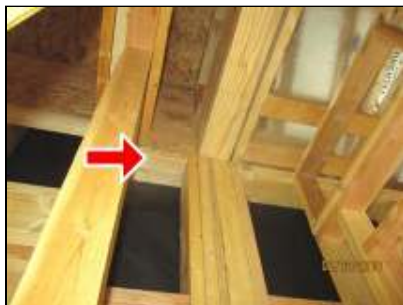
(6) Strapping at bearing points was not seen.

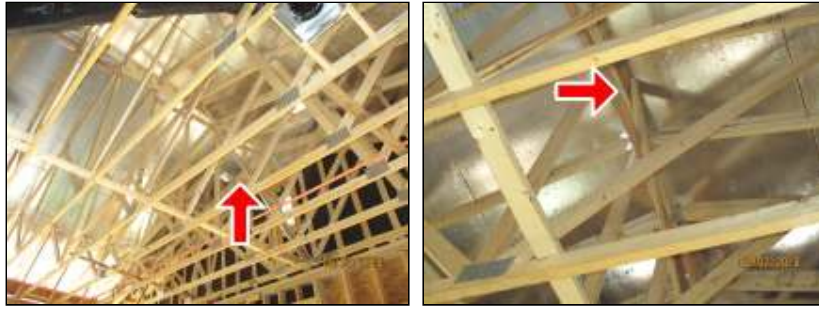
(7) The west diagonal brace needs securing.

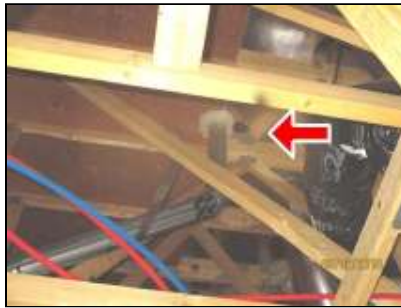
(8) Roof sheathing hole at the dryer vent should be sealed.

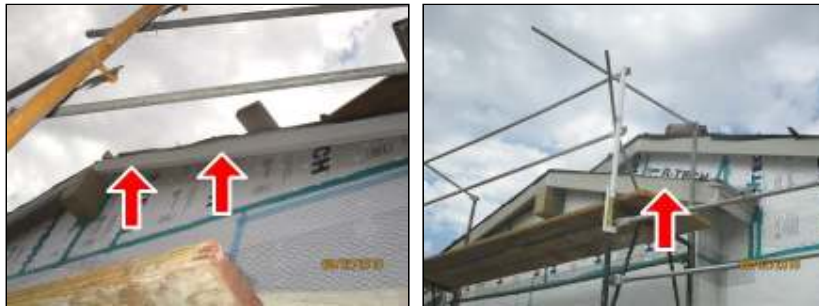
(1) Improper underlayment lap and securing noted at some fascia locations.

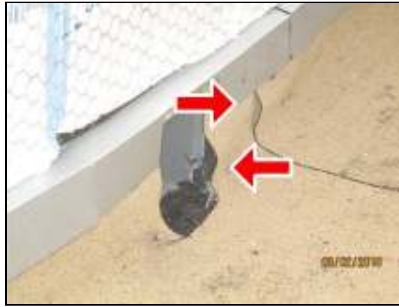
(2) Open seams noted at the rolled comp roof material at the scupper area.

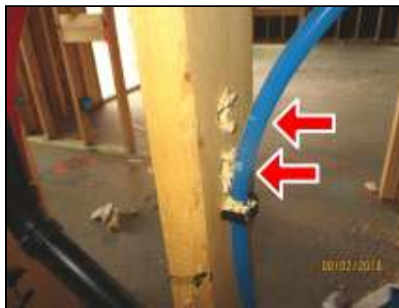
(1) Some pex tubes were damaged by drilled holes.

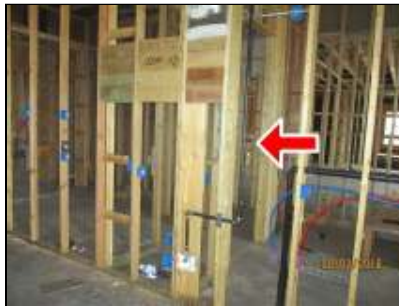
(2) Gas piping at the kitchen is not properly anchored.

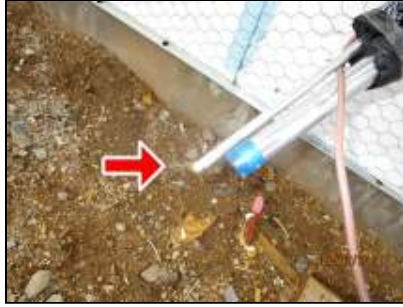
(1) Missing cap at the exterior HVAC refrigerant line.

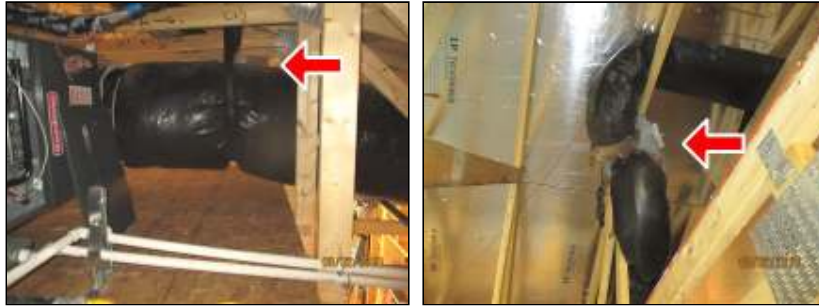
(2) Once the dry wall has been installed, it will be very difficult to access/service the fresh air fan in the attic.

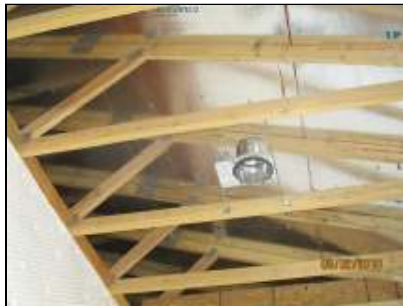
Electric wiring has not yet been installed.

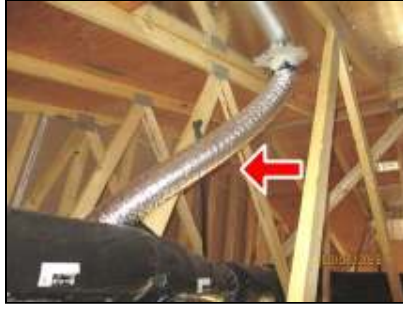
Some fan vent tubes are not properly strapped.
